Experimental Project Annual Report

**EVALUATION OF HIGH DENSITY POLYETHYLENE PIPE (HDPE) CULVERT IN A
MAINLINE APPLICATION**

Project Name:	Angela North & South
Project Number:	STPP 18-1(9)18
FHWA Project Number:	MT 00-09
Project Location:	Highway 59 (P-18); C000018, Rosebud County, Glendive District – RP 23.5-24
Description:	Experimental trial using High Density Polyethylene Pipe (HDPE) culverts in a mainline application
Date of Installation:	August 2007
Report Period:	Spring/Fall 2008
Principal Investigator:	Craig Abernathy Experimental Program Manager

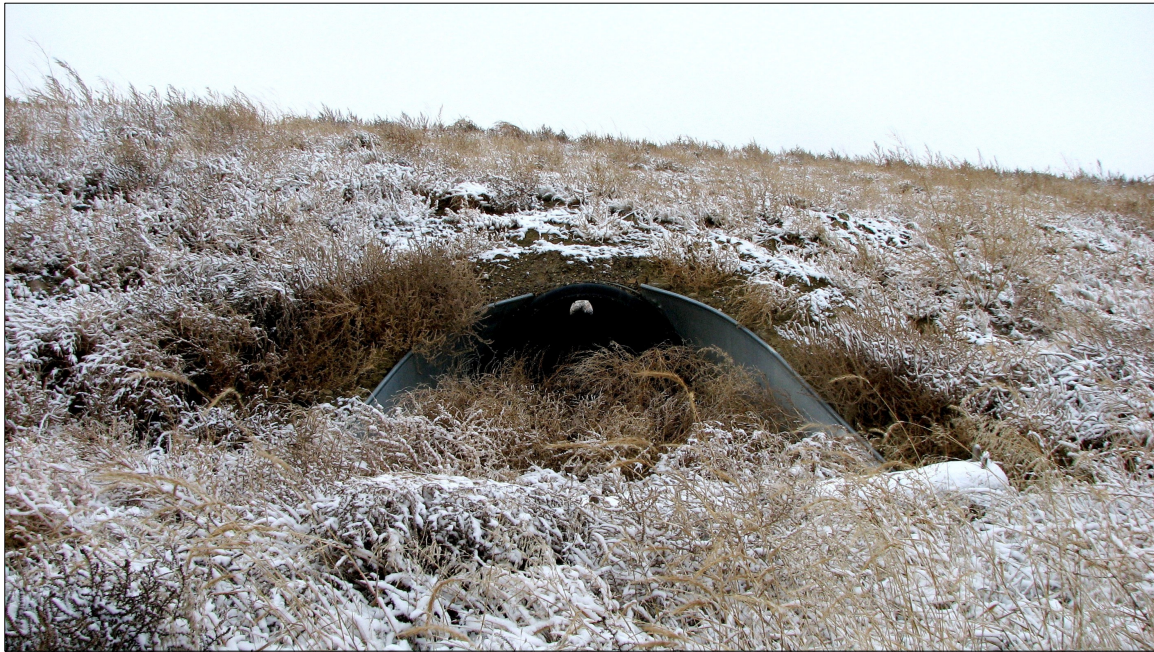
1200mm (48") Inlet

During construction it was noted that the completed HDPE installations had a slight oval shape viewed internally. Measurements taken at random spots within the interior of the 1200mm pipe showed that, on average, the horizontal walls of the pipes had deflected inwardly up to 13mm (.5") to 38mm (1.5") with the vertical (top to bottom) deflection ranging from 13mm (.5") to 19mm (.75"). Measurements taken during the 2007 installation and compared at the same locations within the 1200mm HDPE at the 2008 spring/fall inspections revealed no change in the deflection. Currently it is assumed this initial structural deflection was caused by the compaction process during installation.
